APT 2 & 7 DRY ROT EXTENT AND REMEDICATION PLAN

Petrellen Court

Saturday, 24 August 2024

25 Progress & Actions Identified

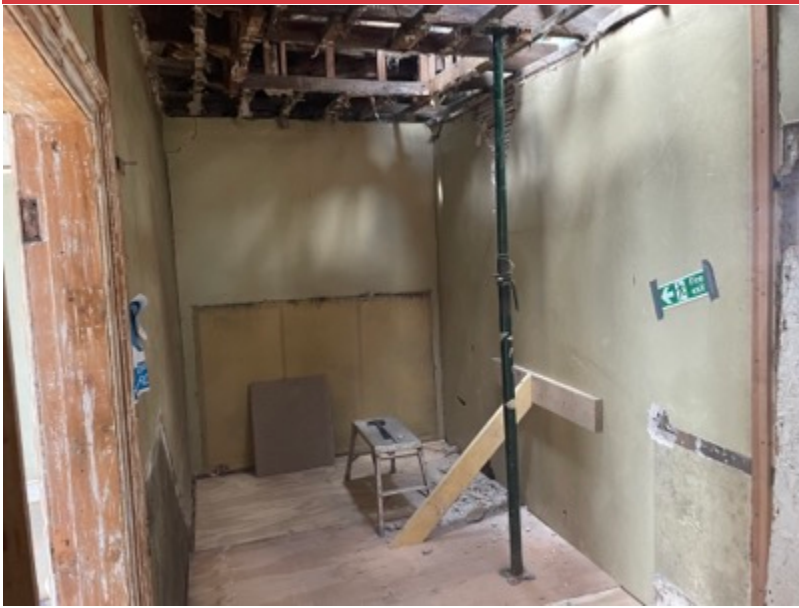
**FLAT 7 BATHROOM/ EN SUITE
PRIOR TO EXPOSURE**

Former Staircase 1st Floor, Dry Rot
Apparent when removing staircase.
Floor Joists installed and
Temporary Deck Laid to Remove
render and Expose Rot

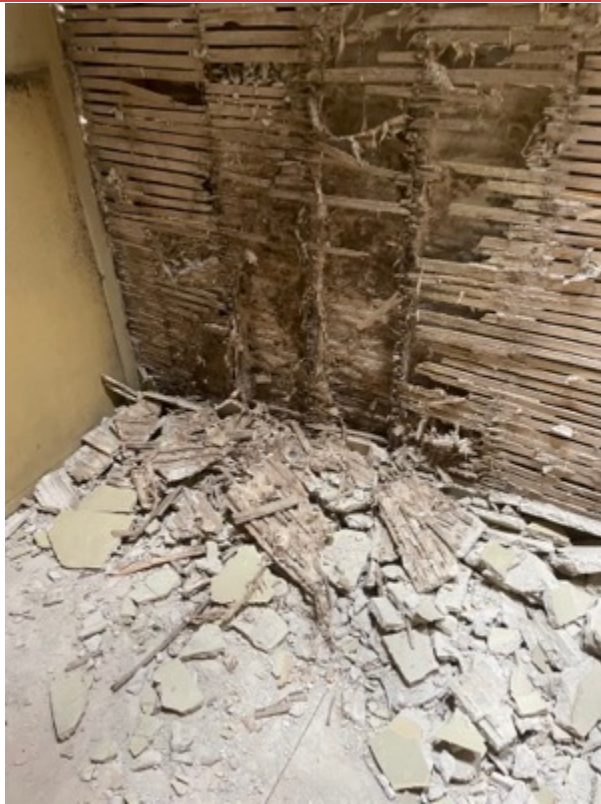
FLAT 7 INITIAL EXPOSURE

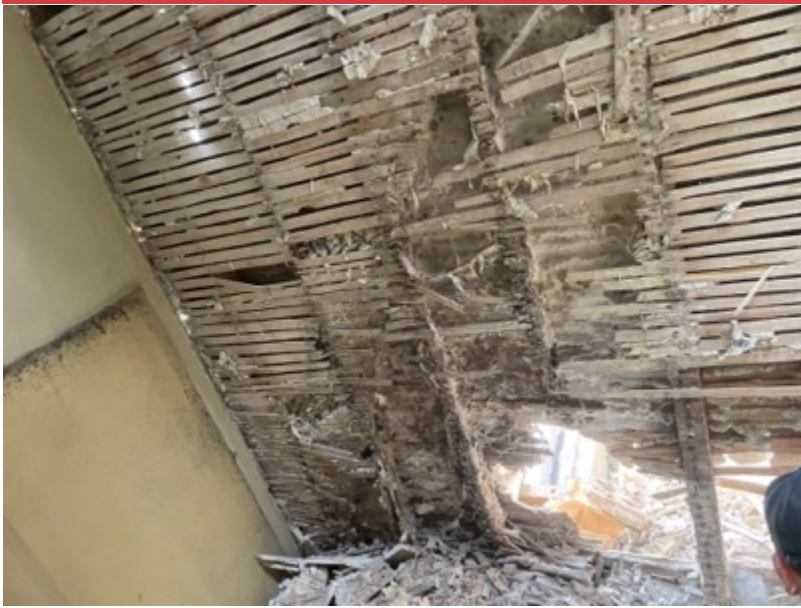
FLAT 7 EXPOSURE CONTINUED

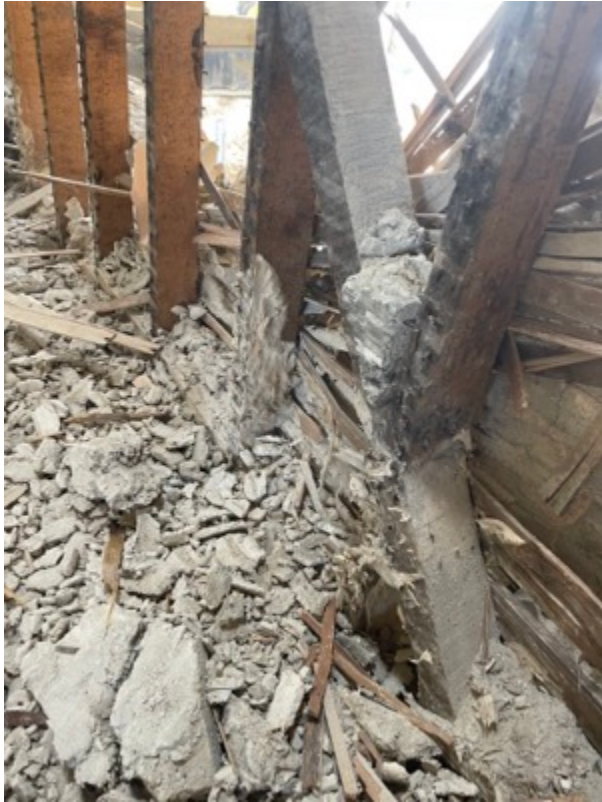
**FLAT 7 EXTENT OF ROT
CONTINUED ALL THROUGH
WALL LHS**

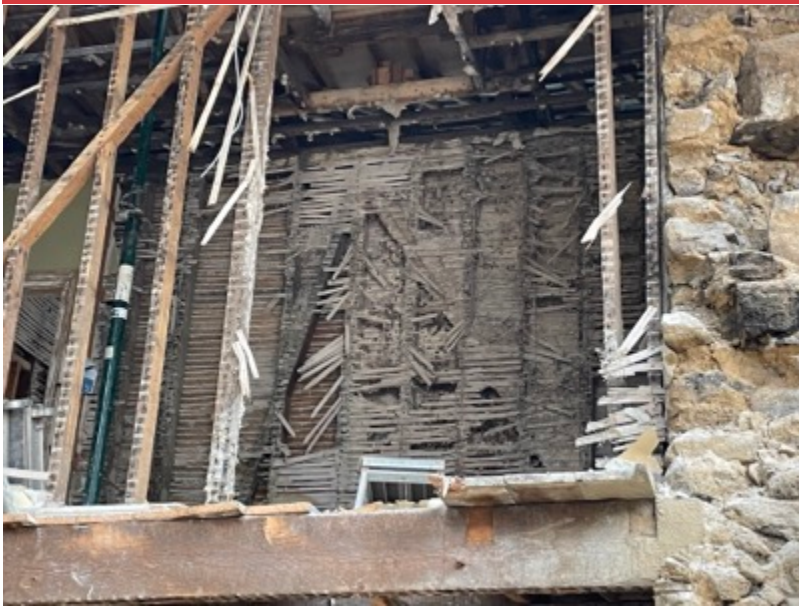
FLAT 7 LHS EXTENT OF ROT

Render Collapsed from wall in 1 sheet(Note Acrows beneath first floor framing down to basement to prevent collapse.)

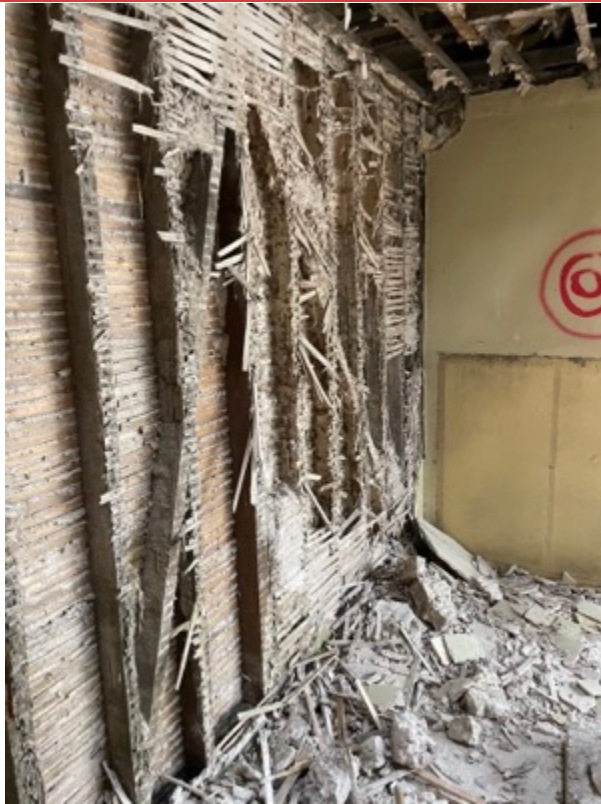
ALTERNATIVE VIEW TO FLAT 7 LHS

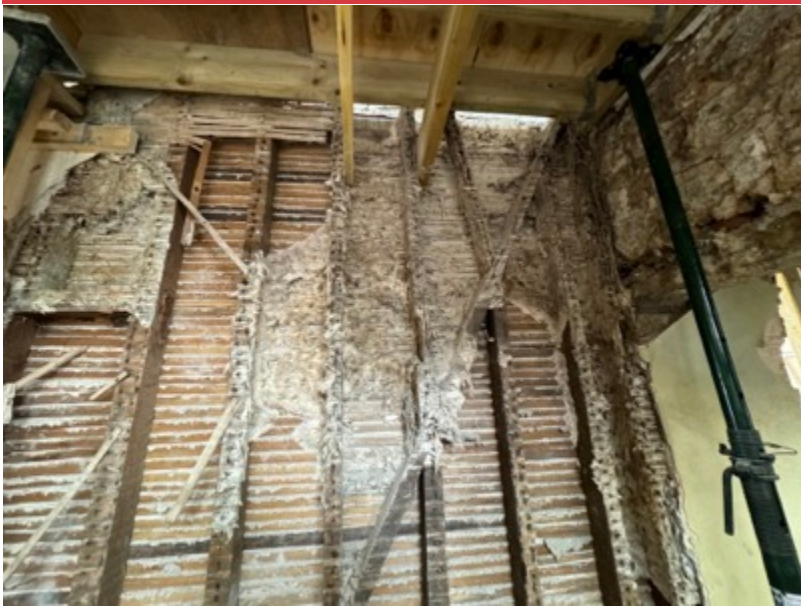
**FLAT 2 LHS WALL BELOW
PICTURES ABOVE**

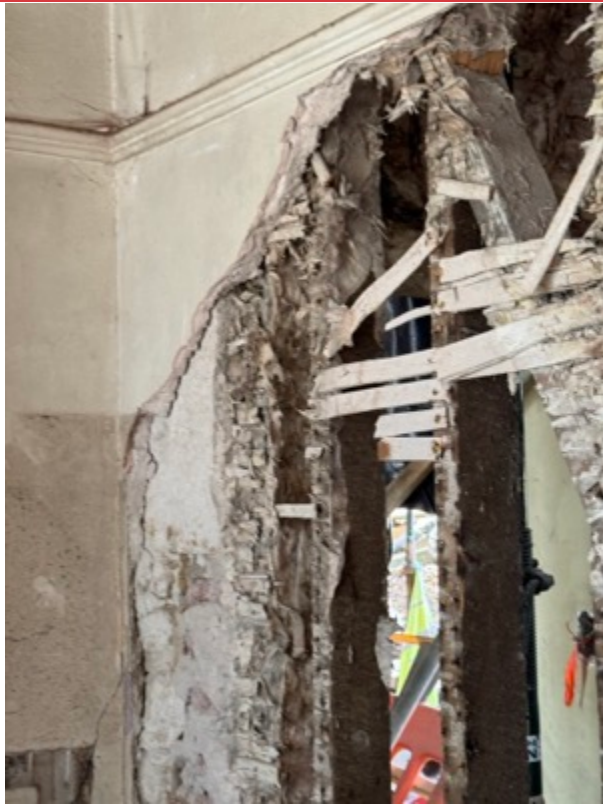
**FLAT 2 LOOKING TOWARDS
MASONRY WALL**

This is the remaining section of the collapsed wall

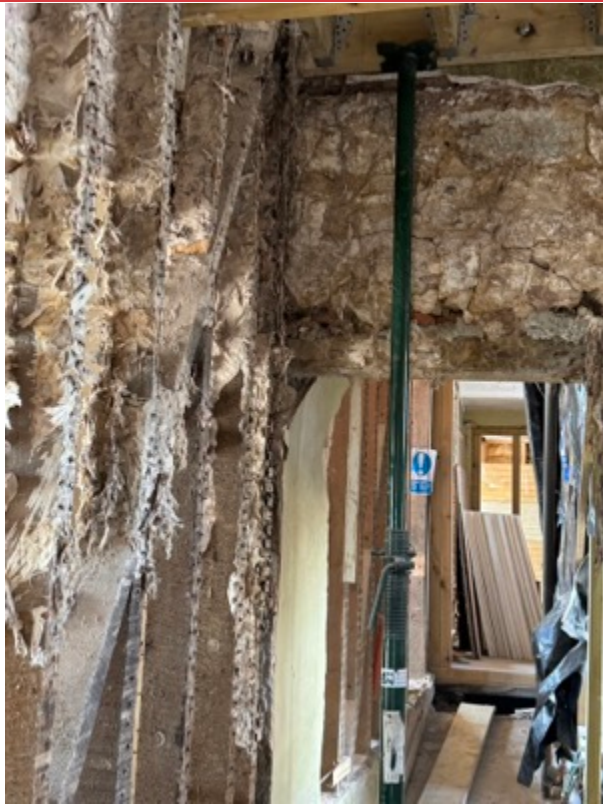
FLAT TWO LHS ALTERNATIVE VIEW

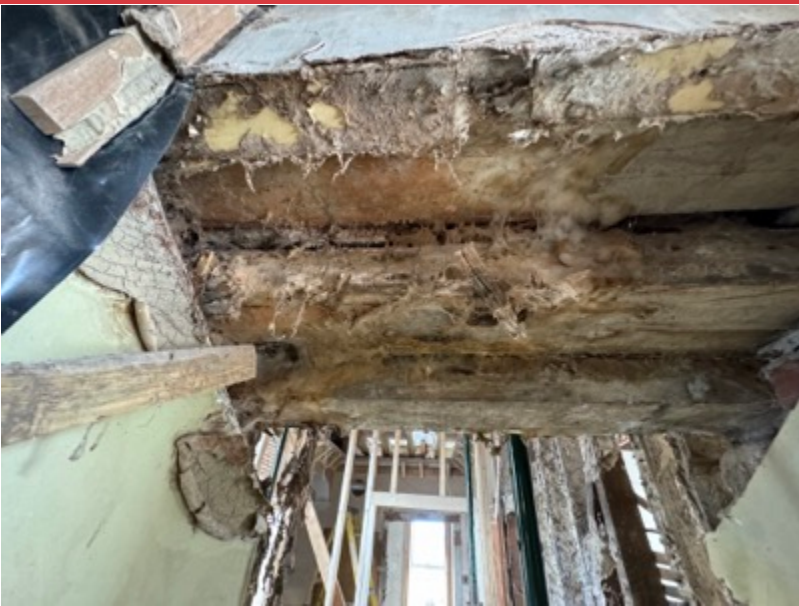
LINTELS TO MASONRY WALL

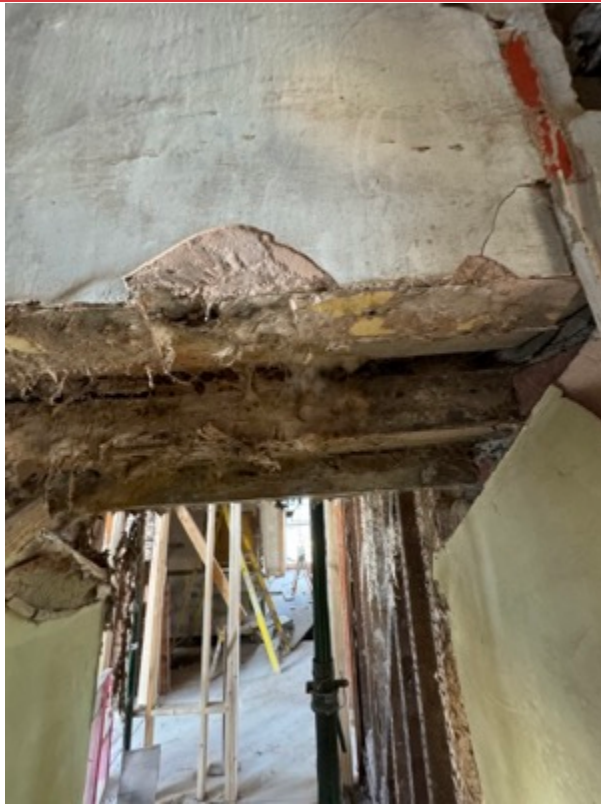
AS ABOVE LOOKING IN

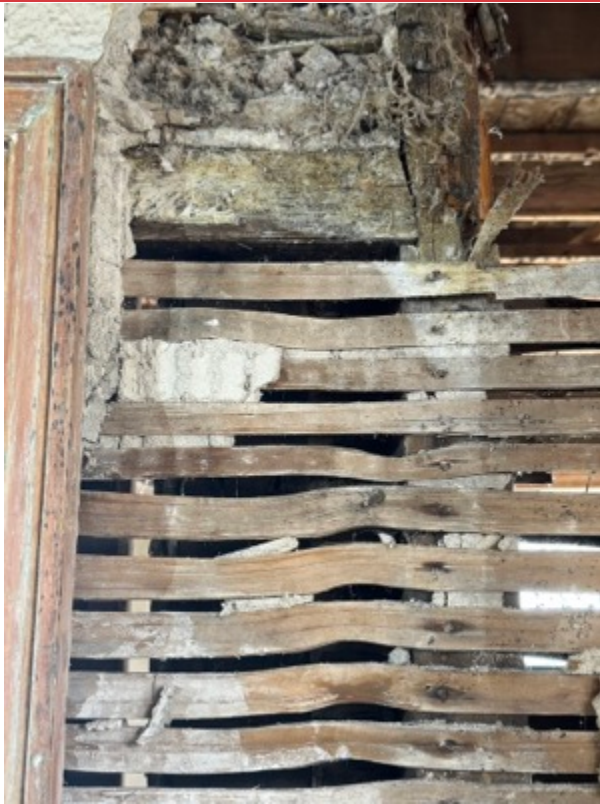
**FLAT 2 LIVING ROOM DOOR
PRIOR TO REMOVAL**

Rot has spread through entire
length of hallway

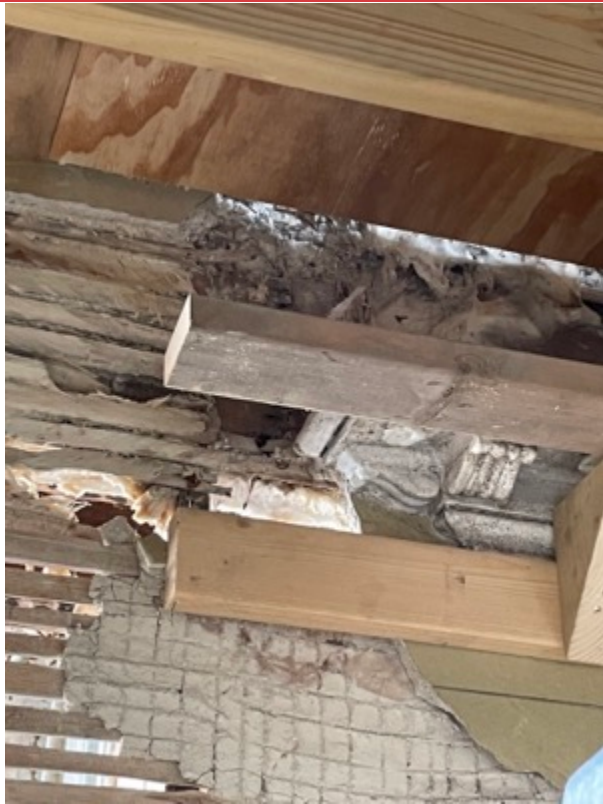
**RENDER REMOVED EXPOSES
ROT BEHIND CORNICE**

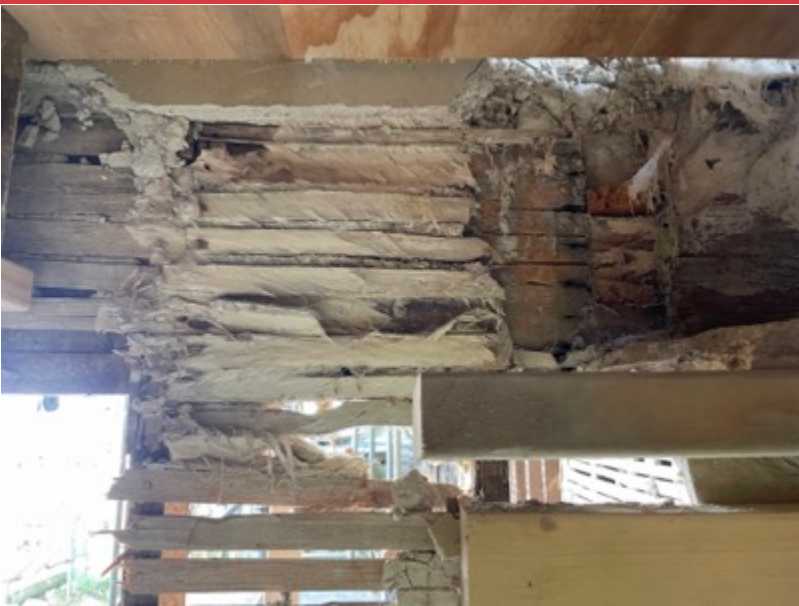
TIMBER LINTEL ROTTEN

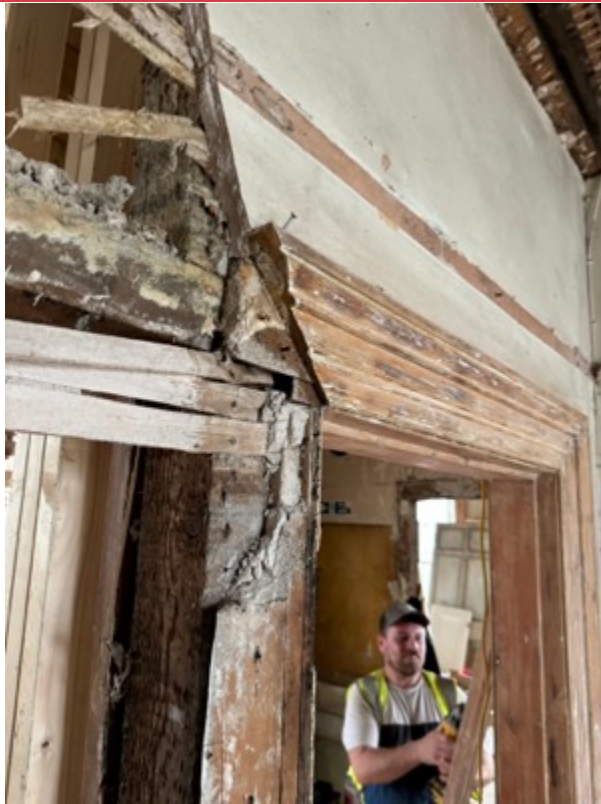
**FLAT 2 BEDROOM 1 DOORWAY
PRIOR TO REMOVAL**

General Note all door frames and
architraves have been retained for
reinstallation once spray treatment
professionally applied

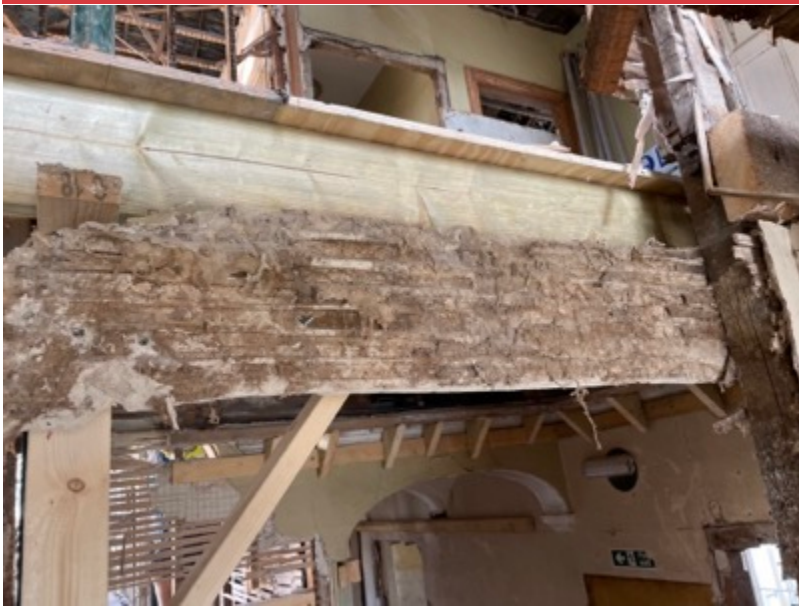
**BACK OF CORNICE ONCE WALL
REMOVED**

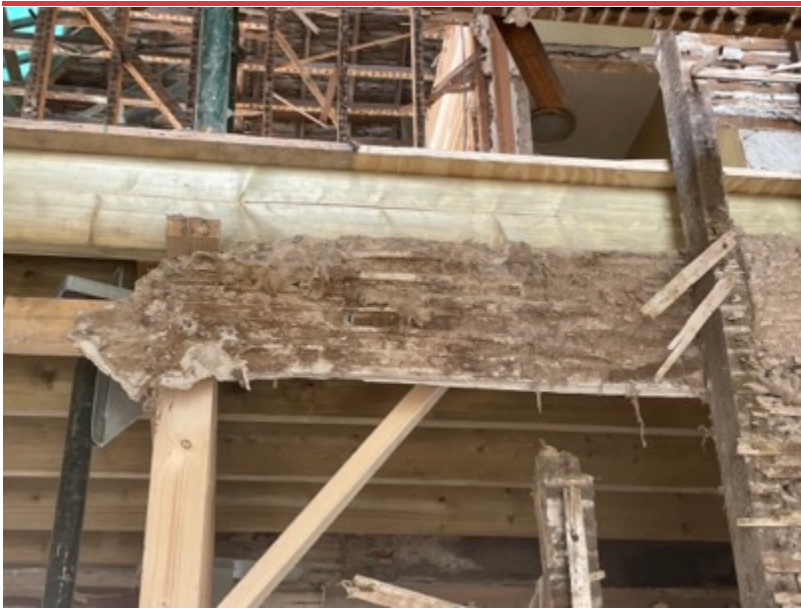
**ALTERNATIVE VIEW BACK OF
CORNICE**

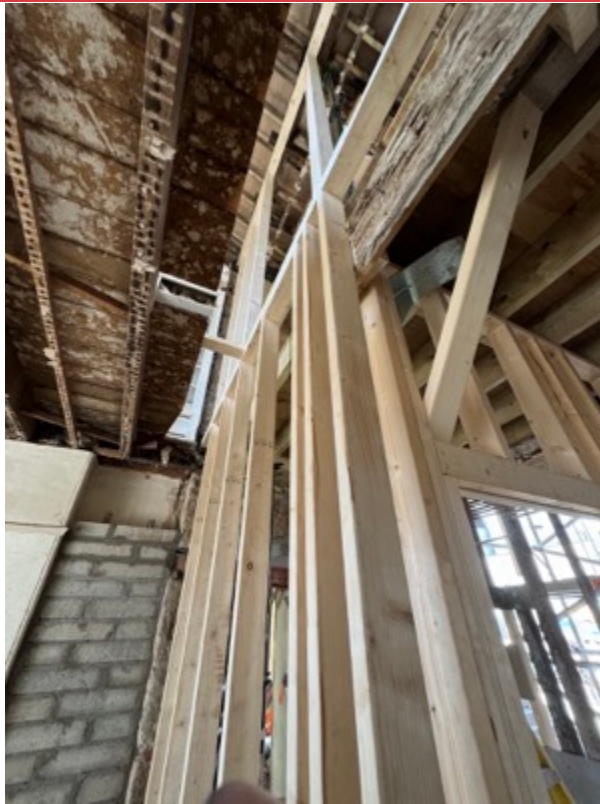
OVER VIEW OF METHODOLOGY FOR REMOVAL AND REPLACEMENT

Removing 3 to 4 Studs at a time and Replacing before moving onwards.

Double Plate used to allow build in sections and continue. All Timbers Joined have had 3 Coats of Sika Guard between them prior to installation as the spray treatment to follow may not penetrate between.

DPC have been used in addition to provide physical barrier as well as chemical where new timber meets old timber. Existing Timbers have also been treated where timber plates connect to them.

The Intention behind doing 3 to 4 timbers at a time is to allow us to replace the structure as we go. The cornice (Now cleaned of rot) can then be reconnected to the new installation as we work through.

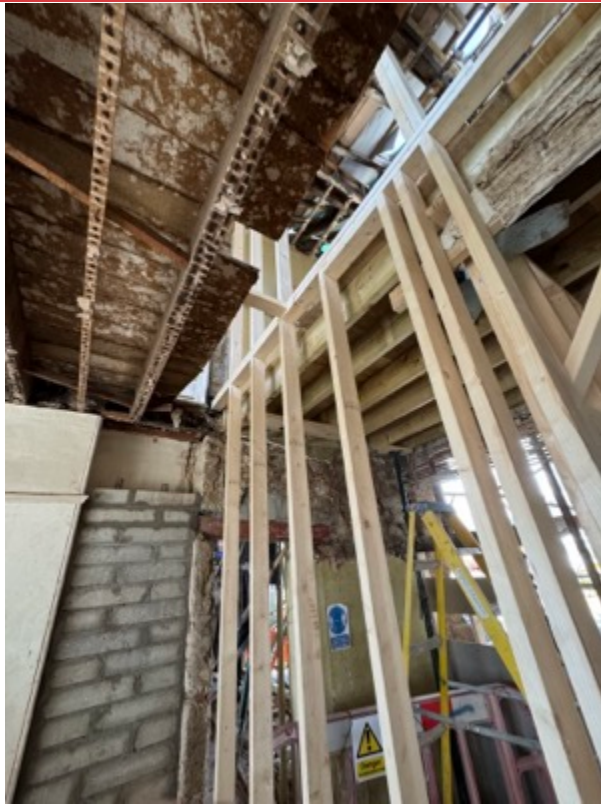
AS ABOVE ALTERNATIVE VIEW
